Intel[®] Mobile Pentium[®] II Processor Specification Update

Release Date: October 2000

Order Number: 243887-025

The Mobile Pentium[®] II processor may contain design defects or errors known as errata which may cause the product to deviate from published specifications. Current characterized errata are documented in this Specification Update.

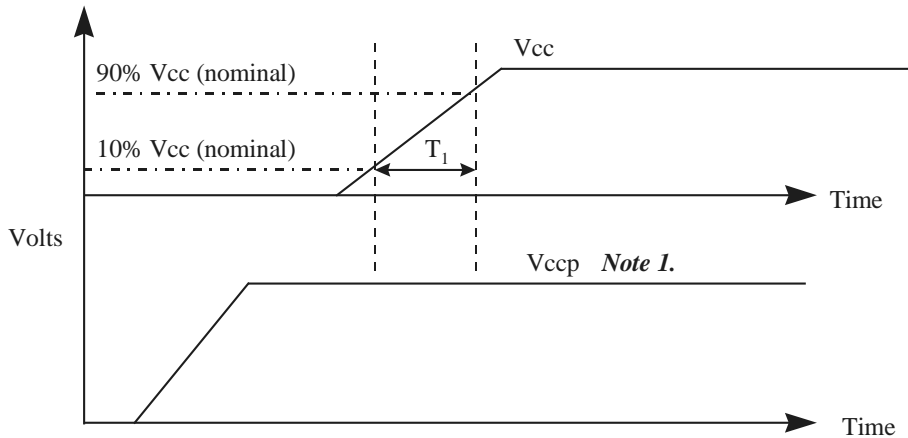
Figure 1. V_{CC}/V_{CCP} Timing Requirements (Mobile)

Problem: The processor uses the PWRGOOD signal to ensure that no voltage sequencing issues arise; no pin assertions should cause the processor to change its behavior until this signal is asserted, when all power supplies and clocks to the processor are valid and stable. However, if V_{CC} ramps up before V_{CCP} , it will cause the processor to enter an invalid state.

Implication: If this erratum occurs, the system may boot normally however, the L2 cache may not be initialized.

Workaround: For Mobile Pentium II processors, ensure that V_{CC} ramps after or with the L2 cache IO voltage (V_{CCP}). If V_{CCP} ramps after the V_{CC} , a delay circuit can be placed on the core V_{CC} to ensure that V_{CC} ramps at the same time or after V_{CCP} as shown below in Figure 1.

Symbol	Parameter	Min	Max	Notes
T_1	V_{CC} Ramp Time	200 μ Sec		Measured between 10% V_{CC} (nom) to 90% V_{CC} (nom)
Note 1: V_{CCP} must be greater than V_{CC} during the interval in which V_{CC} rises from 20% V_{CC} to 80% V_{CC} .

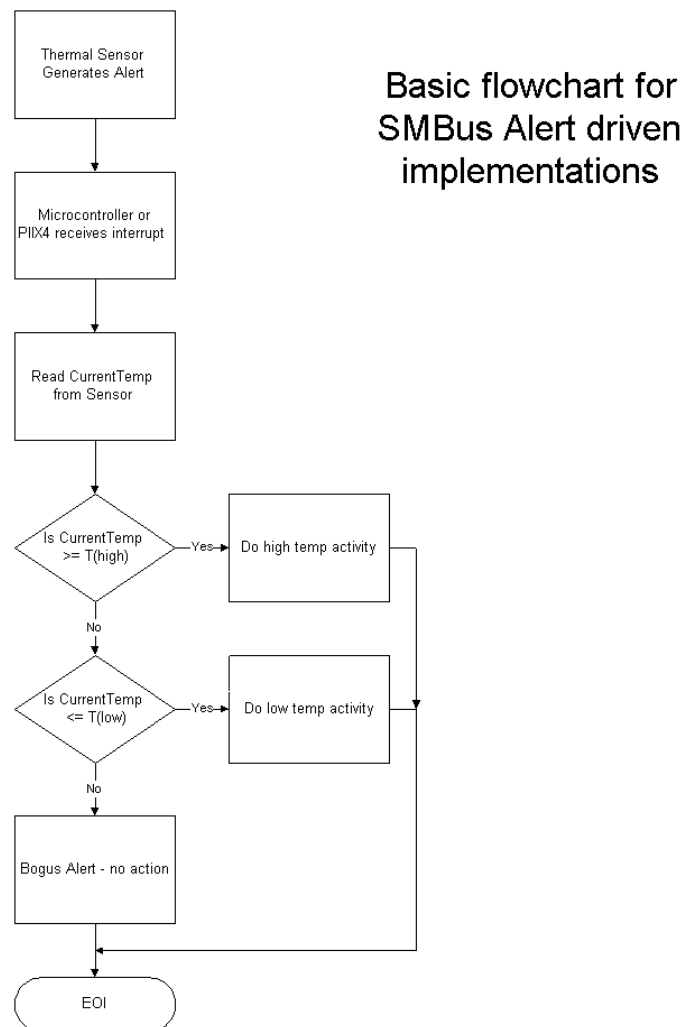
Figure 2. Workaround Flowchart: SMBALERT#-Driven System

Under the conditions described below, the thermal sensor incorrectly generates the SMBALERT# interrupt. All of the following conditions must be met to trigger a false interrupt:

1. Before servicing an interrupt from the thermal sensor, read and compare the processor thermal reading with the threshold limits (T_{HIGH} or T_{LOW}). Figures 2 and 3 provide basic flowcharts for the implementation of this workaround in an interrupt driven system.
2. If the firmware implemented polls the Status Register only, then before taking any action, re-read the temperature register and do a comparison with the alarm threshold limits (T_{HIGH} or T_{LOW}) to determine if the value is actually still within the temperature window.

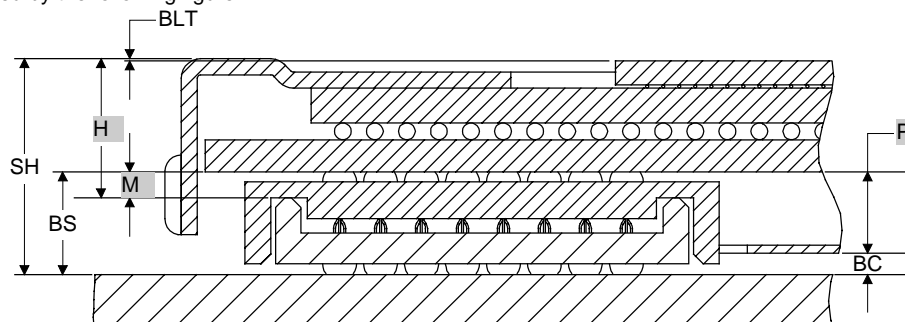
Figure 5.6. Cross Sectional View with Vertical Dimensions

B1. Mislabeled Vertical Dimension Parameters

Figure 5.6 in the *Mobile Pentium® II Processor at 233 MHz, 266 MHz, and 300 MHz* datasheet should be replaced by the following figure:

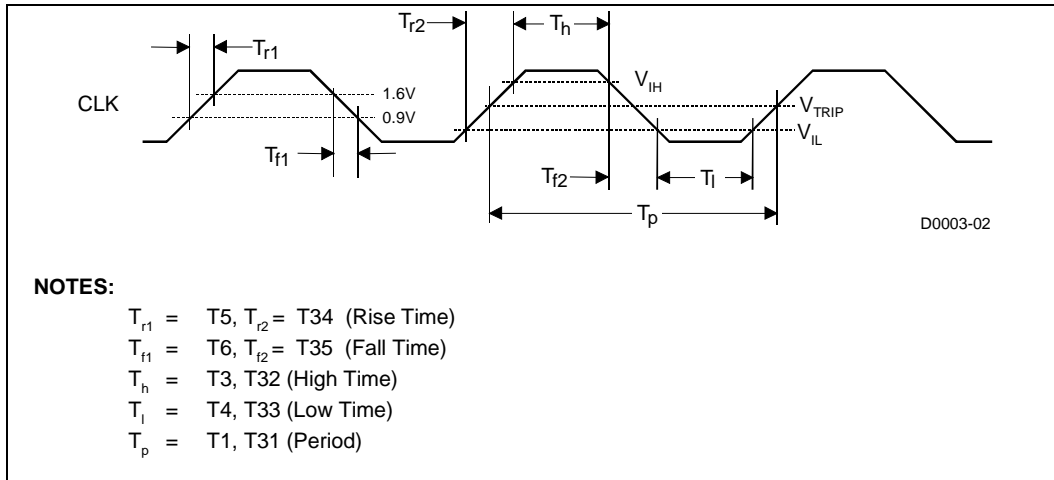
Figure 3.3 Generic Clock Waveform

B14. Generic Clock Waveform Figure

Figure 3.3 in *Mobile Pentium® II Processor in Mini-Cartridge Package at 366 MHz, 333 MHz, 300PE MHz, and 266PE MHz* datasheet (Order Number 245108), and the *Mobile Pentium® II Processor in BGA Package at 366 MHz, 333 MHz, 300PE MHz, and 266PE MHz* datasheet (Order Number 245106) has been updated. The following figure is to replace the ones in the above documents.
